# San Fernando, California, Earthquake of February 9, 1971

U.S. DEPARTMENT OF COMMERCE  
National Oceanic and Atmospheric Administration

*Part B. Buildings continued; Soils and Foundations*

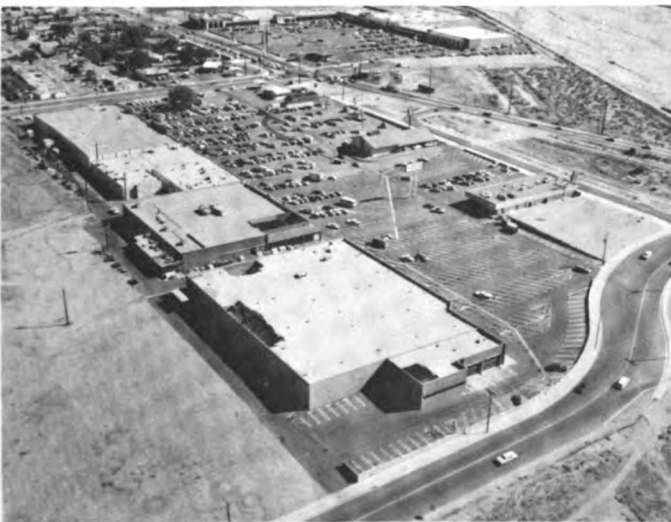
Figure 2.—W. T. Grants (foreground). Note three areas (dark) of roof collapse. Builder's Emporium (11) is just above W. T. Grants. Department of County Engineer photograph.

along the north wall for a length of about 145 feet, along the north wall of the west wing for about 50 feet, and along the east wall for a length of about 30 feet (figs. 2, 3, 4, and 5). In each of these areas the 4- by 16-inch or 6- by 16-inch purlins were framed perpendicular to the wall. The wall was forced out of plumb by as much as 8 to 9 inches. Several other areas of the roof diaphragm sustained cracked roofing and distorted plywood. An interior wood stud bearing wall supporting the mezzanine floor joists displaced and required repairs.

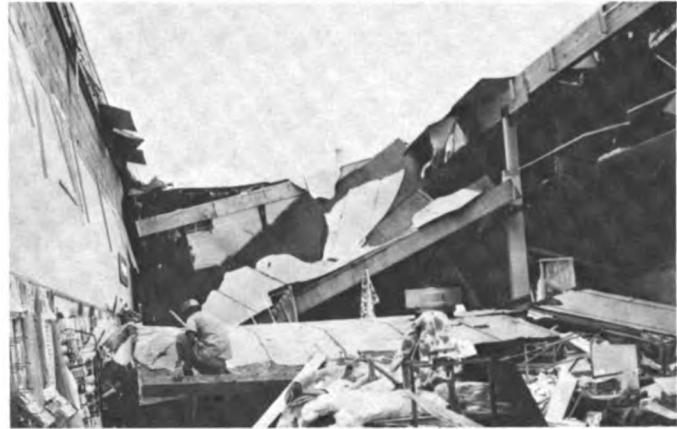
Figure 3.—W. T. Grants. Collapsed roof along north wall. J. F. Meehan photograph.

mode of failure. Generally, the areas of fallen roof are where the 4- by 16-inch purlins span between the exterior wall and the girder on the first column line inward from the wall. Typically, there is no framing continuity through the girder line, except for the plywood that is staggered over the girder. A line of separation (diaphragm tension failure) occurred at and parallel to the girder. With edge nailing at 6 inches on center and boundary nailing at 4 inches on center, the number of nails required to fail at the girder line is approximately 20 for each tributary width (8 feet) between the purlins. The number of nails required to fail along the wall line is 24. Since alternate boards are staggered over the girder, eight of the 20 nails at that point are required to be installed in one-half the width of a 2 by 4, or about  $\frac{3}{4}$  inch. Along the wall, the boundary nails are in a 4X member and the full width is available for nailing. The reduced edge distance (about  $\frac{3}{8}$  in.) and reduced member width may reduce substantially the nail strength. It is suggested that the lateral load supporting system, provided by the roof framing for the top of the wall for forces perpendicular to the wall, may actually have begun to fail at the first girder inward from the wall line. The fewer number of nails and, in some cases, reduced edge distance, may be the weak link in the stress line. As the plywood begins to separate along the girder line, the purlins are pulled off their hanger seats and drop. The added force of the falling roof elements pulled the plywood-ledger connection apart at the wall line, and the whole roof area collapsed.

The concrete block walls were repaired by jacking them back into place in some areas, and by replacing them with new materials in other areas. Additional ledger bolts through the walls, with steel plate washers both inside and outside, were installed. Bolted continuity ties through the first girder line parallel to the walls were installed as part of the repair work.

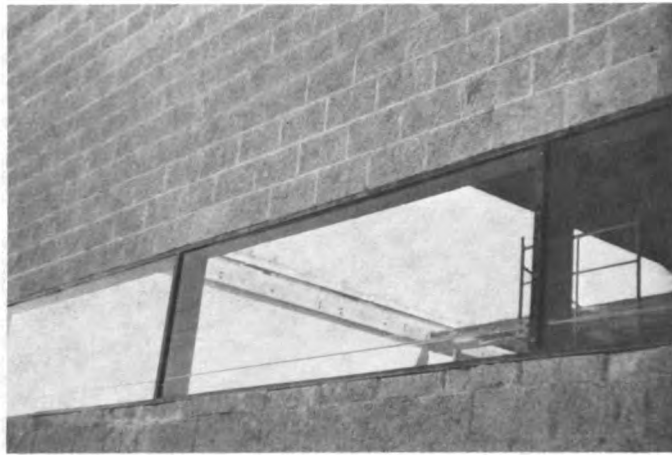
Figure 4.—W. T. Grants. Collapsed roof at west wing.  
J. Kesler photograph.

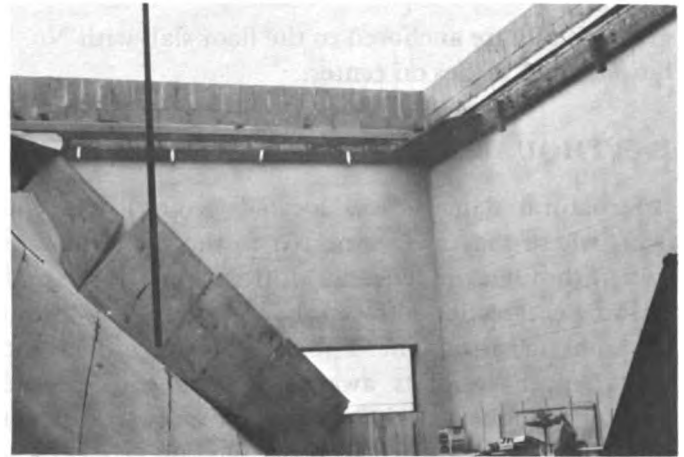
Figure 5.—W. T. Grants. Collapsed roof at west wing.  
J. F. Meehan photograph.

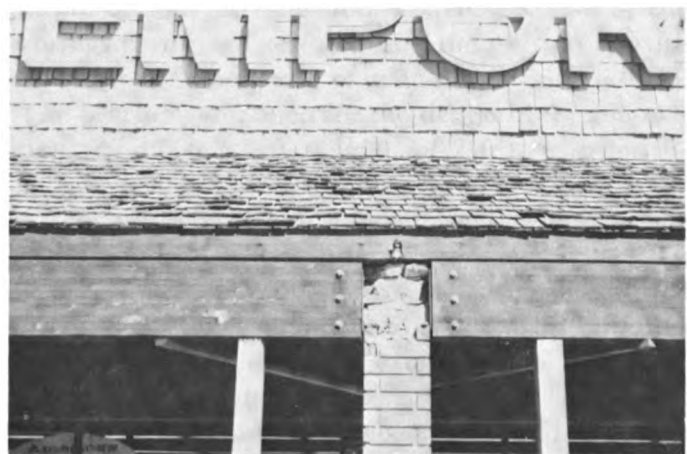
Girders (7 by 18 in.) along the south wall canopy line were loosened from their supports at the masonry columns at three locations (fig. 1, section D-D, and fig. 4). The seismic axial forces in the girders were large enough to fracture the masonry column by pull-out (tension) on the anchor bolts and by compression against the column face. The masonry was fractured and loosened to the extent that spalling occurred at the face of the column.

Figure 4.—Builder's Emporium. South wall girder connection with outside masonry spalled off. J. Kesler photograph.

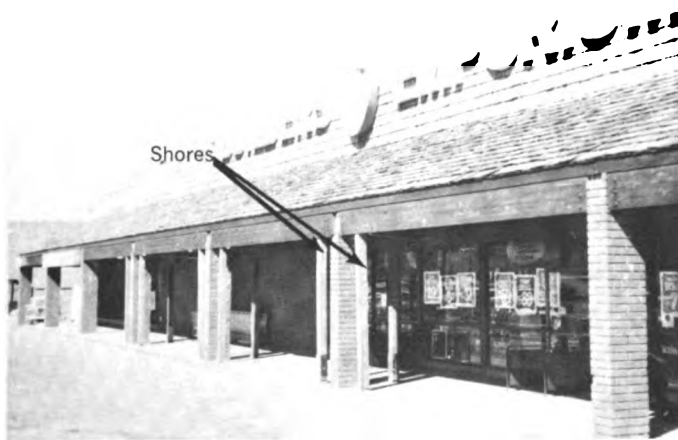
Figure 3.—Builder's Emporium. South wall. Note shores adjacent to columns. J. Kesler photograph.

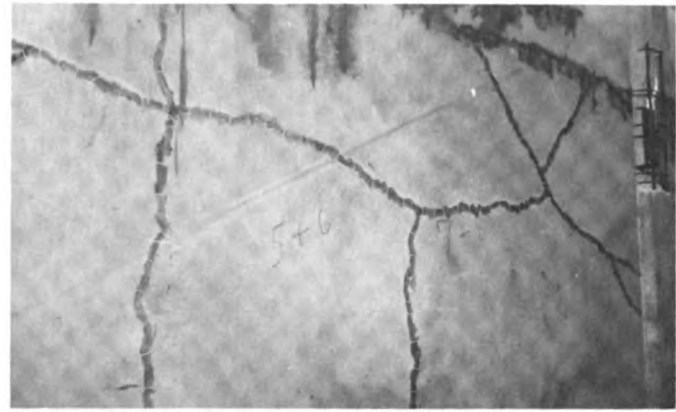
Figure 7.—Alpha Beta Market. Epoxy-patched cracks in precast concrete wall panel at line 6. Wheeler & Gray photograph.

Reinforced precast concrete panel walls were damaged extensively by cracking of the concrete. Even though the majority of the cracks were already repaired, they still were clearly visible (fig. 7). A definite pattern of cracking could not be detected, as the cracks occurred in vertical, horizontal, and diagonal directions. Some separation between the poured-in-place pilaster and the precast panels could be seen, but it could not be established if they were earthquake-induced or existed previously.

Pipe columns on line 4, leaning about 4 inches toward the east, were straightened during repairs. All cracked concrete walls were to be pressure injected with epoxy compound, and concrete pilasters were to be gunited after proper preparation of the affected area (fig. 9). Completion of structural work was to be followed by repair of architectural items such as finishes, ceilings, fixtures, and others.

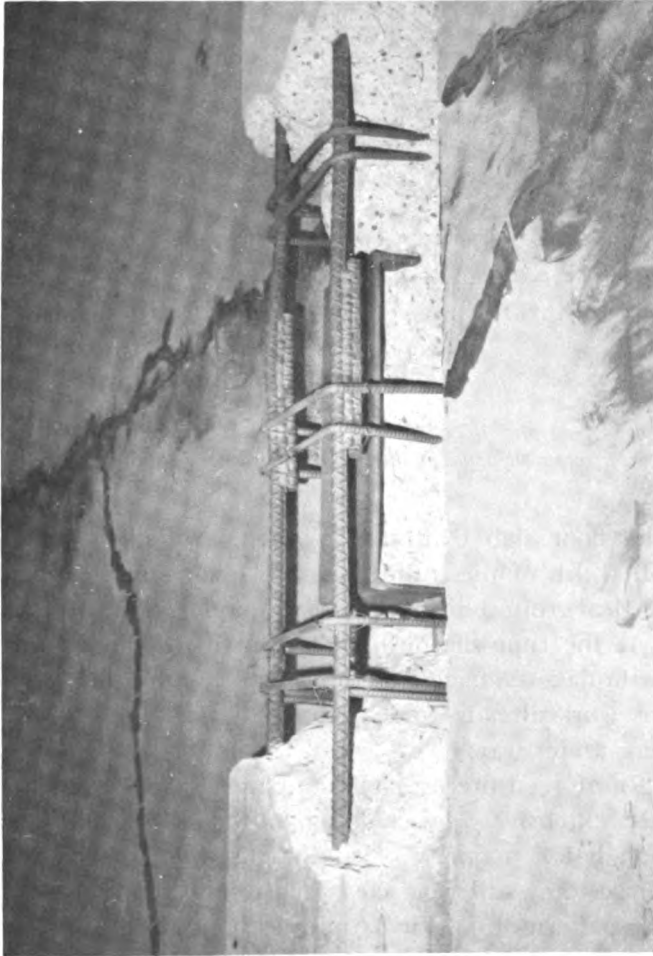
The poured-in-place concrete pilasters (wall columns), located between the precast wall panels, almost without exception suffered heavy damage at the points where the steel beams from the higher roof and the tapered steel girders from the lower roof connect to them (fig. 5, section 18-18). It is known that the girder anchor bolts were connected through 3-inch-long slotted holes, burned in the bottom flanges of the girders for erection purposes. Considerable movement between girders and wall pilasters undoubtedly contributed to the damage at these connections. Serious cracking and spalling of the concrete, which in some instances extended to adjacent panels, took place at those points (figs. 8, 9, and 10).

Figure 8.—Alpha Beta Market. End of tapered steel girder from adjacent lower roof. Wheeler & Gray photograph.

The effect of differential movements between two structures of different stiffnesses was clearly indicated by damage sustained to pilasters at connections with tapered steel girders from lower roofs (figs. 8, 9, and 10). Also, cracking of concrete wall was much more pronounced in side walls with adjacent lower buildings than in end walls, where no lower construction existed. As in other buildings investigated and cov-

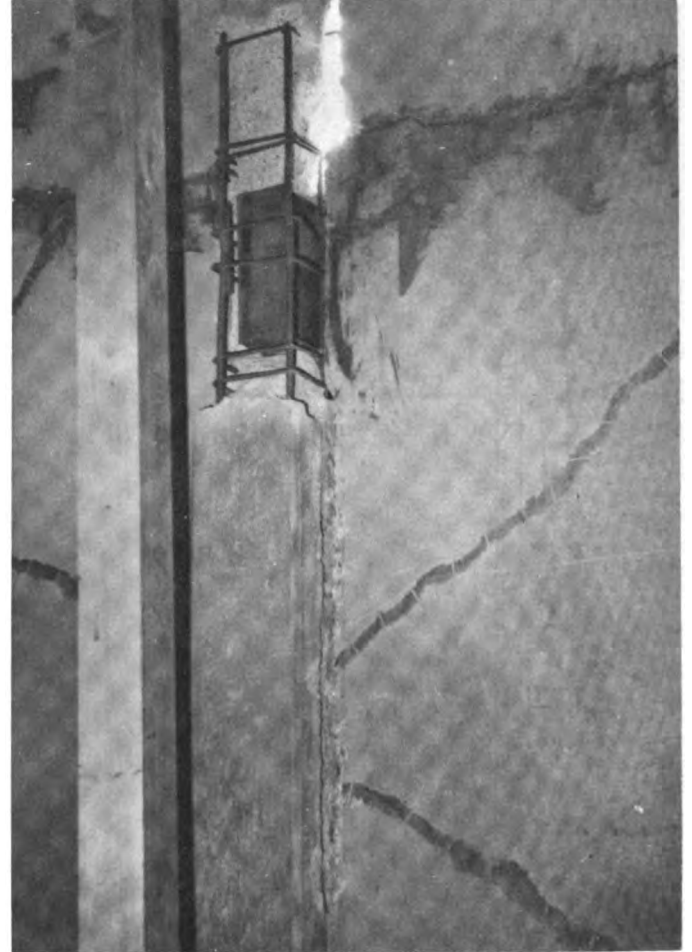
Figure 9.—Alpha Beta Market. Damage inflicted to wall and pilaster by end of tapered steel girder. Temporary shoring at left. Wheeler & Gray photograph.

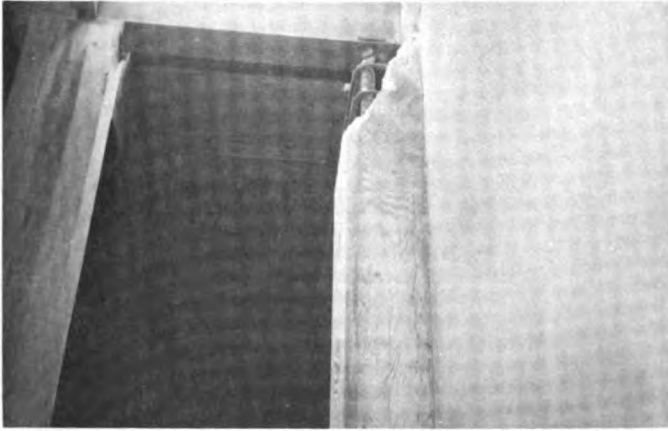
Figure 10.—Alpha Beta Market. Top of concrete pilaster at connection with steel beam. Wall line 6. Wheeler & Gray photograph.

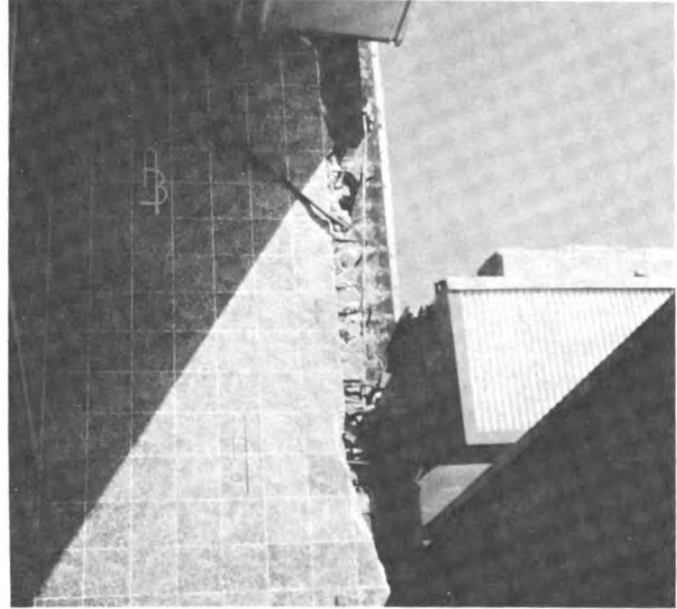
The two reinforced brick walls on the south side of the main building, providing the lateral stability in an east-west direction, sustained severe cracking

and partial breakage of bricks (figs. 11 and 12). The author was not able to see the walls since they had already been removed, but personal descriptions indicated that the major extent of the damage took place in the lower portions of the wall near the floor slab.

Figure 12.—Alpha Beta Market. Front (south) shear wall, looking east. D. F. Moran photograph.

The reinforced brick shear walls were removed completely and replaced by reinforced gunited con-

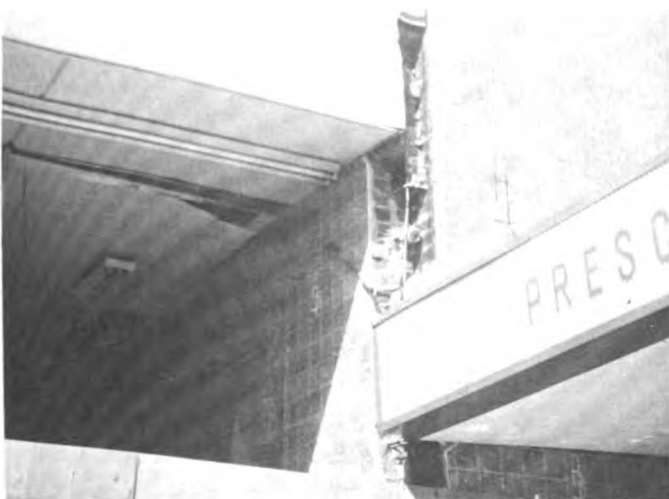
Figure 11.—Alpha Beta Market. Front (south) shear wall. D. F. Moran photograph.

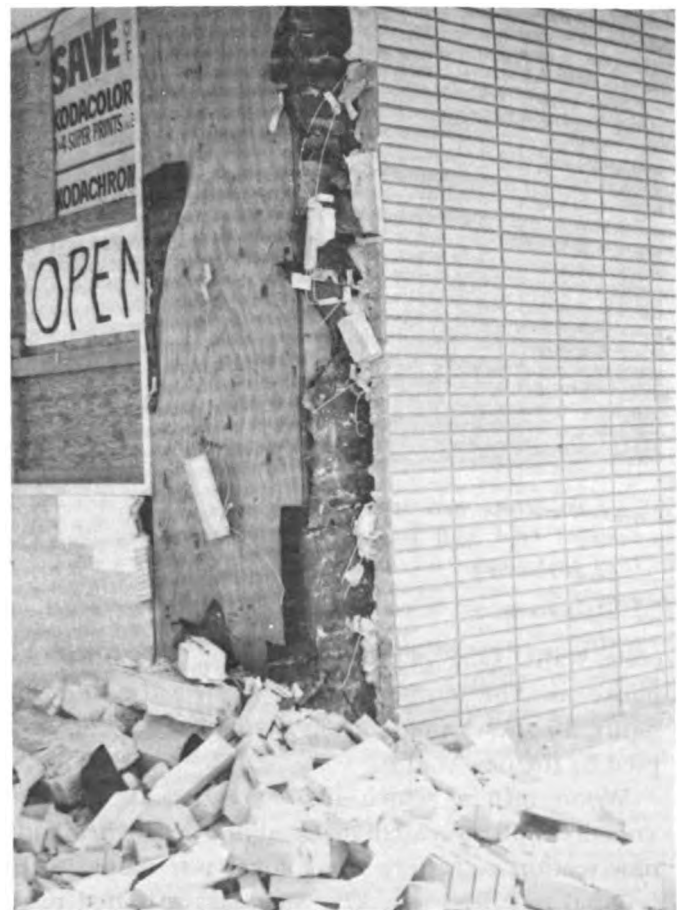
Figure 13.—Alpha Beta Market. Southeast corner of building east of market; brick veneer broke loose from its stud wall backing. Wheeler & Gray photograph.

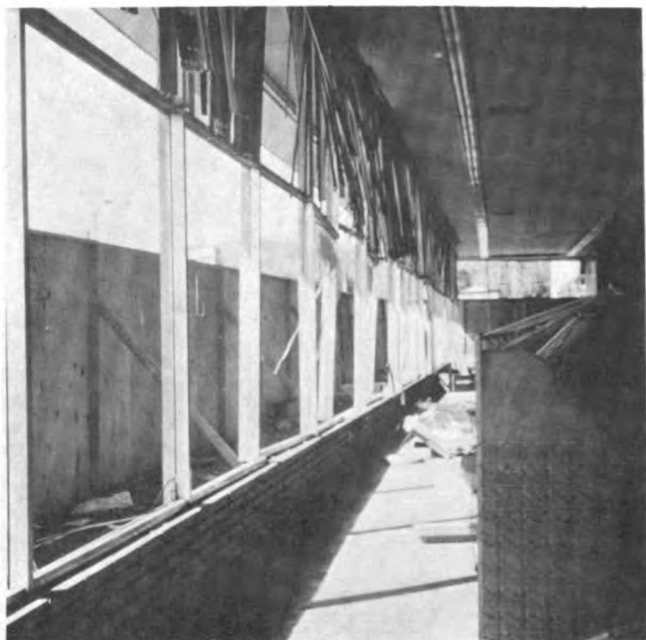
Widespread damage to nonstructural items occurred throughout the building. Most of the glass window wall at the front of the market cracked and collapsed (fig. 14). Acoustical tile soffits buckled and spalled off, wall finishes cracked, lighting fixtures broke loose from their supports and fell to the floor, and most of the market merchandise spilled from the shelves.

*Figure 14.—Alpha Beta Market. Front (west) curtain wall.  
D. F. Moran photograph.*

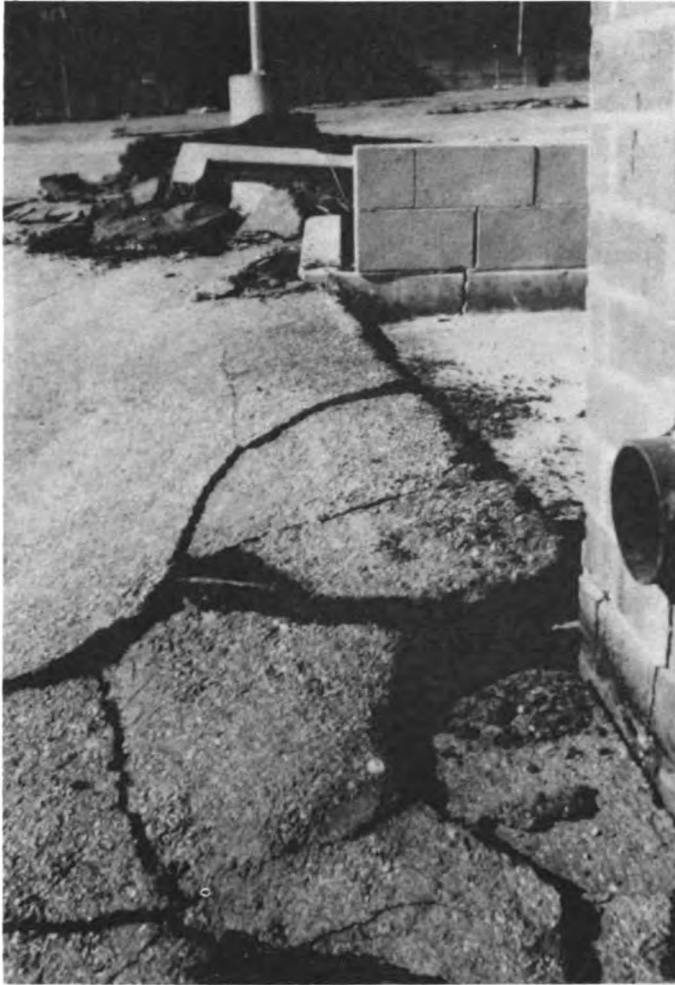
*Figure 5.—Southwest corner of bowling center. Looking west, approximately 100 feet east of Boys Market. Area ground movement. Note offset in curb in near background. LeRoy Crandall & Associates photograph.*

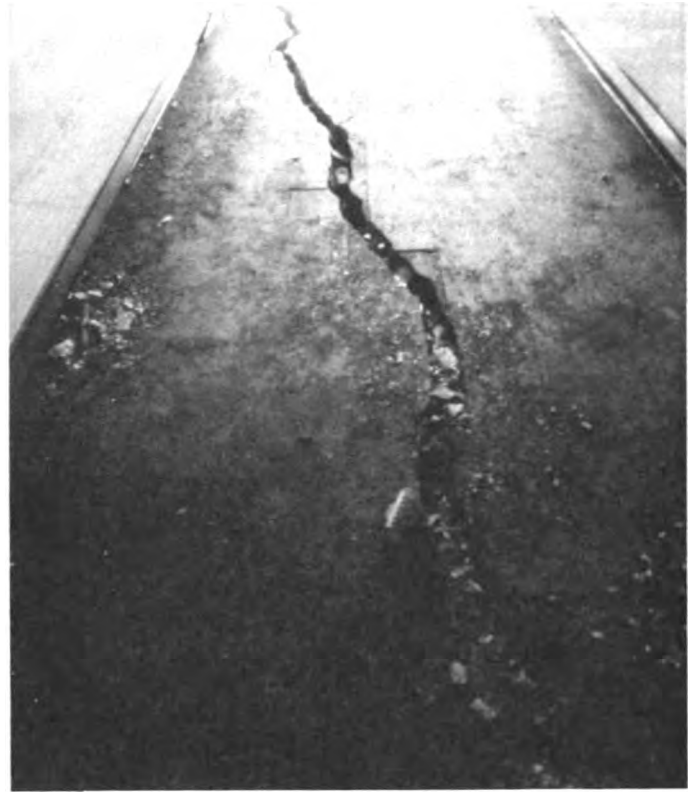
*Figure 6.—Boys Market. Typical north-south crack in building floor. LeRoy Crandall & Associates photograph.*

The market building floor was cracked badly. One of the typical cracks is shown in figure 6. It was reported that the open cracks were in the range of 4 inches in width, with differential vertical displacement in the same range at several locations. All observed floor cracks were thought to be tension cracks.

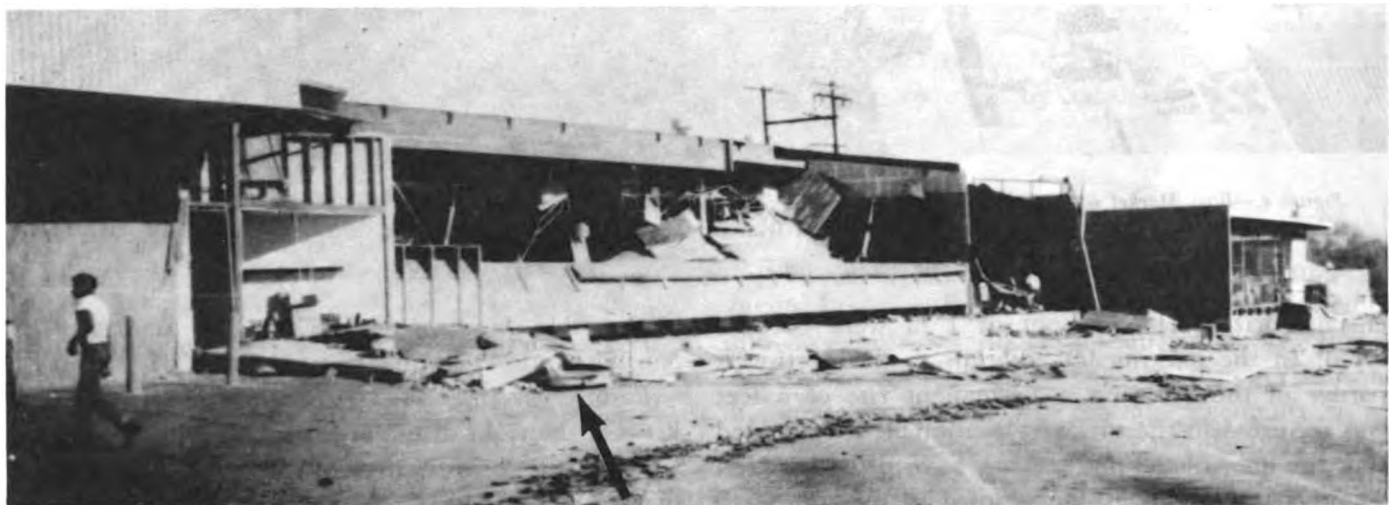
*Figure 7.—Boys Market, looking toward location of south wall. Note trunk of auto in center of photograph under fallen wall. LeRoy Crandall & Associates photograph.*

The masonry portion of the south wall, west of the loading dock, lost its lateral support during the earthquake and fell. The first bay of roof framing also fell to the ground. Figure 7 is looking toward the location of the south wall. Although the roof beams, rafters, and sheathings separated from the east wall, the wall remained in place. Figures 8 and 9 show how the beam seats along the east wall were torn apart. It was noted that approximately one-half of the ledgers bolted to the wall were ripped down.

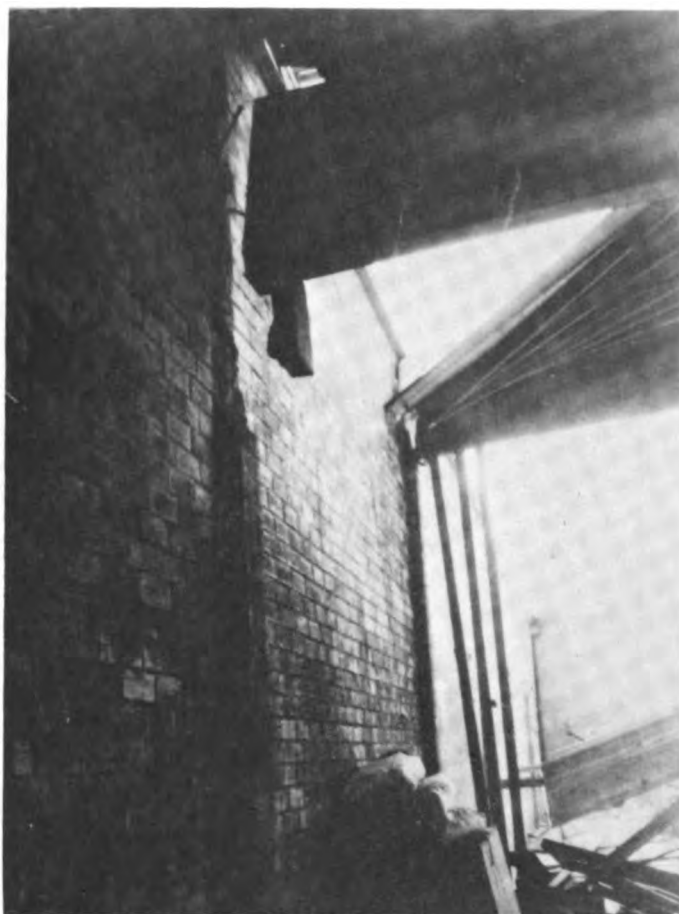
Figure 8.—Boys Market. East wall, showing roof beams torn from their seats. LeRoy Crandall & Associates photograph.

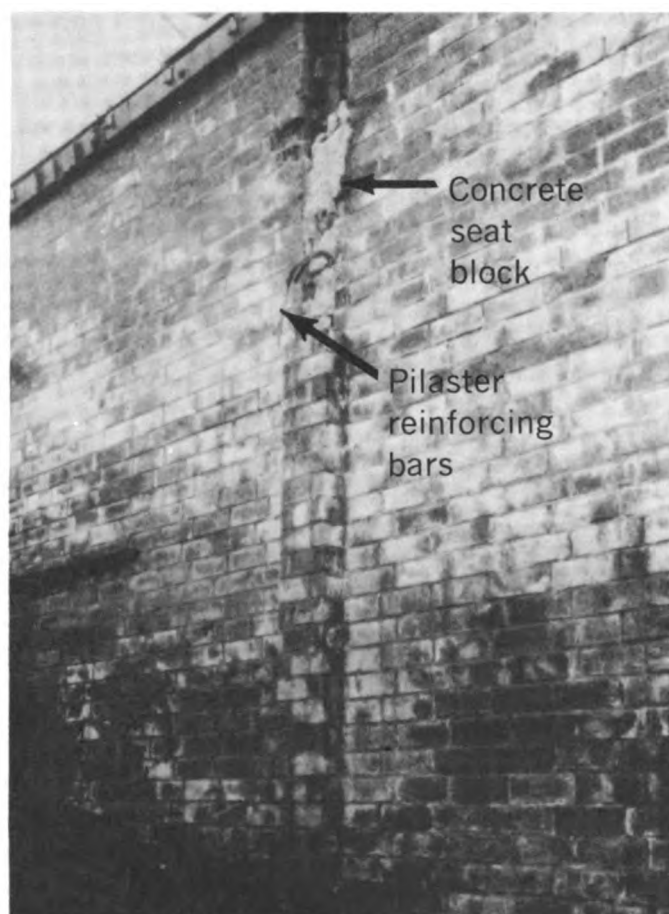
Figure 9.—Boys Market. Closeup of roof beam seat. Note broken concrete bearing block and reinforcing bars which are bent down the wall. LeRoy Crandall & Associates photograph.

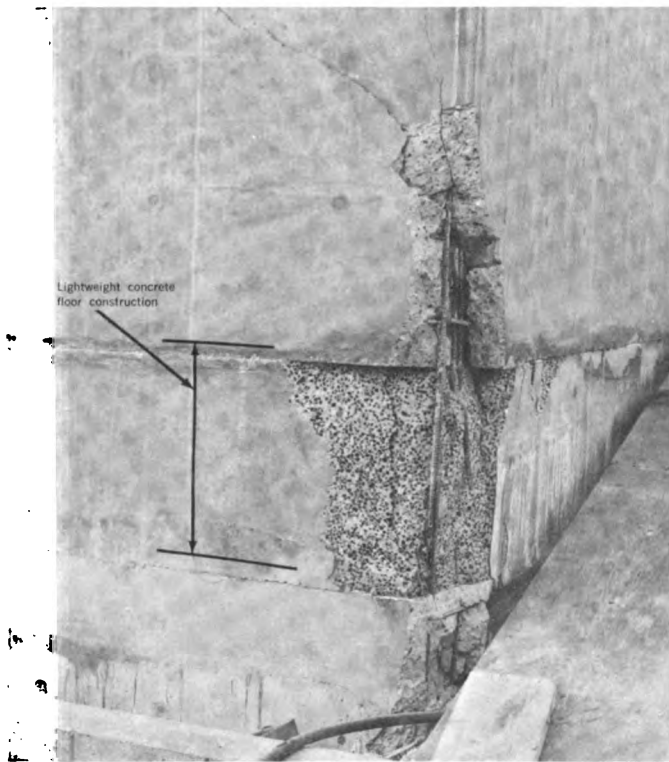
On the faces of the walls where differential movement took place, spalling was prevalent along the failure line. The spalling is apparent in figures 7 and 8. The typical No. 4 vertical wall reinforcing bars along the horizontal construction joint in the north and south walls were broken; many in the south wall were broken in two places. The broken bars were

Figure 7.—Museum for Antique Cars. Exterior northeast corner of museum building at first floor. Note lightweight concrete from slab extending through wall.

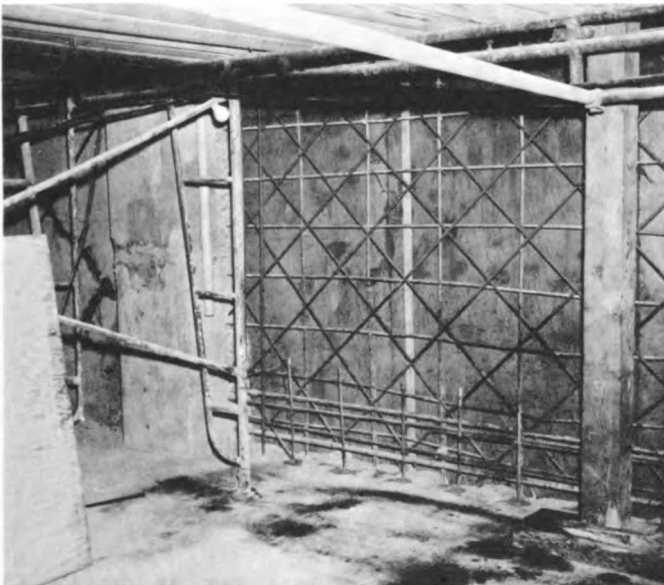
Figure 11.—Museum for Antique Cars. Reinforcing in place in wall panel to be replaced. Typical of north and south wall.

The fractures along the slippage or shear planes at the horizontal construction joints were repaired by developing keys across the joints. The keys were made by drilling interlocking cores through the walls. The cores were centered vertically on the horizontal construction joints and located at the vertical wall reinforcing steel. Typical keys are shown in figures 9 and 10. The horizontal area of the keys is about one-half the total horizontal area of the wall. Drypack was placed to develop the required shear across the plane. In areas where the typical wall steel had broken, the bars were welded together to reestablish continuity, with pieces of reinforcing bar or steel flat plate used as splices.

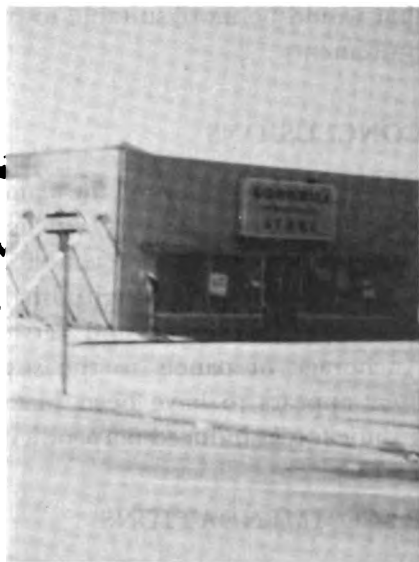
Figure 2.—Goodwill Industries. Precast walls are braced for safety following earthquake. J. Thompson photograph.

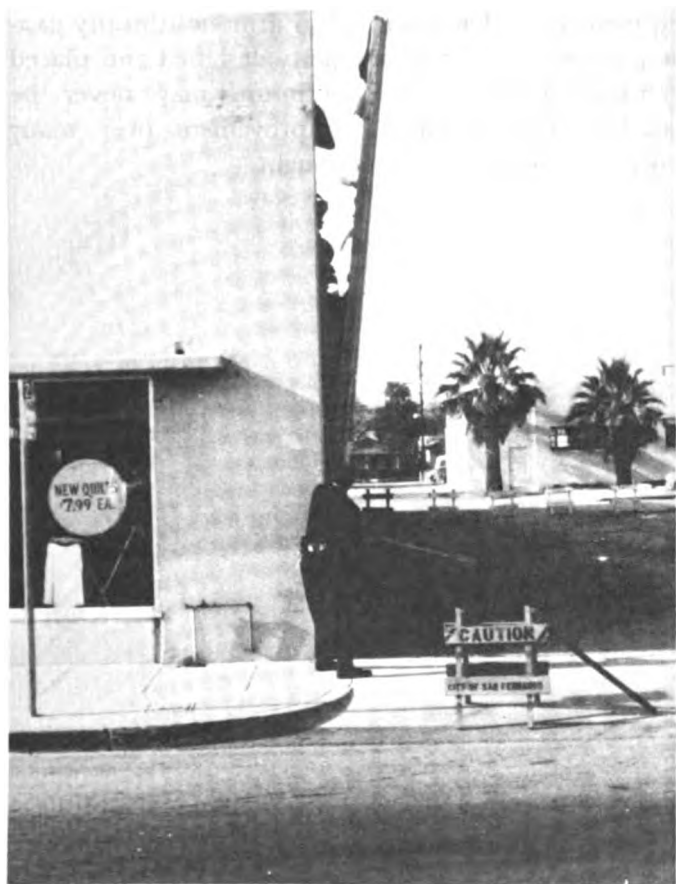
Figure 3.—Goodwill Industries. Precast panel leaning at front corner. Rudy Gunnarson photograph.

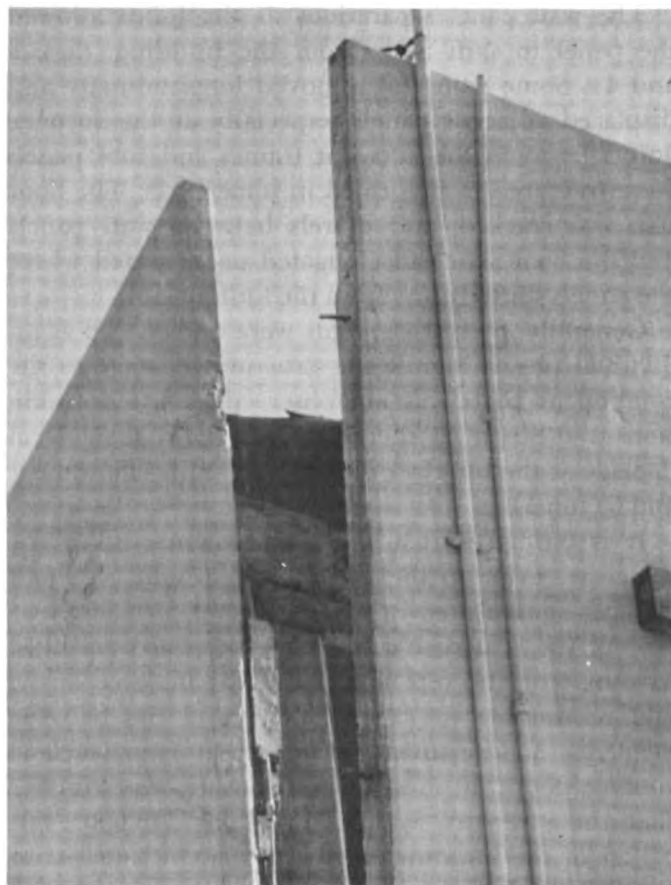
Figure 4.—Goodwill Industries. Northeast corner. Note short dowels from concrete wall. D. F. Moran photograph.

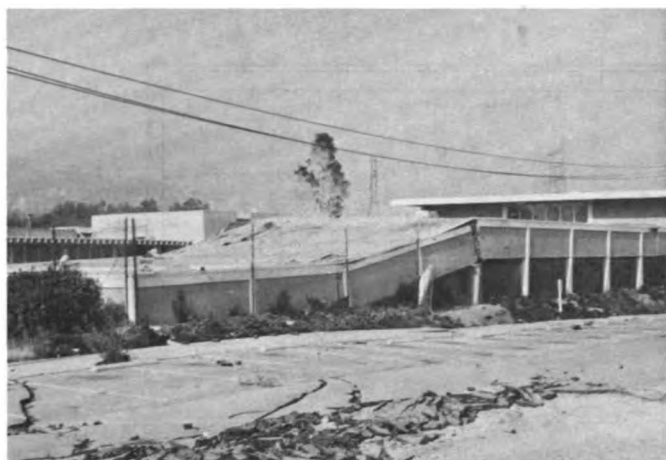
the northeast quadrant as indicated on the roof plan (fig. 2 and figs. 4 through 8). About 40 feet of block wall near the northwest corner and about 6 feet near the northeast corner collapsed under the falling roof. The principal north-south shear wall (12-in. block, stacked bond) was damaged very heavily, sustaining cracks from  $\frac{1}{4}$  to about 12 inches wide (figs. 3, 9, 10, and 11). Massive cracking occurred between the north end of the 12-inch wall and the first duct hole near the top of the wall, and along the top of the wall between duct holes. The north portion of

Figure 4.—San Fernando Valley Juvenile Hall. West wing of Administration Building, looking northeast.

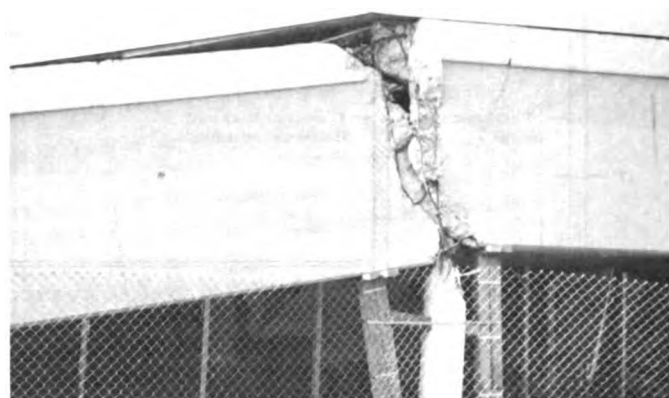
Figure 6.—San Fernando Valley Juvenile Hall. West wing of Administration Building. South wall line roof beam at main fracture line.

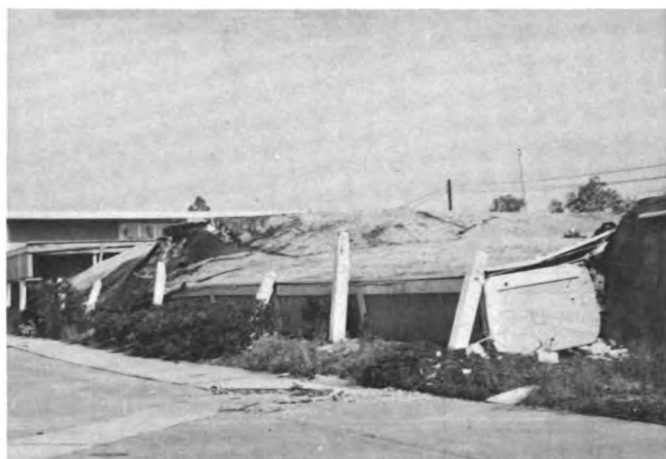
Figure 5.—San Fernando Valley Juvenile Hall. West wing of Administration Building, looking southeast.

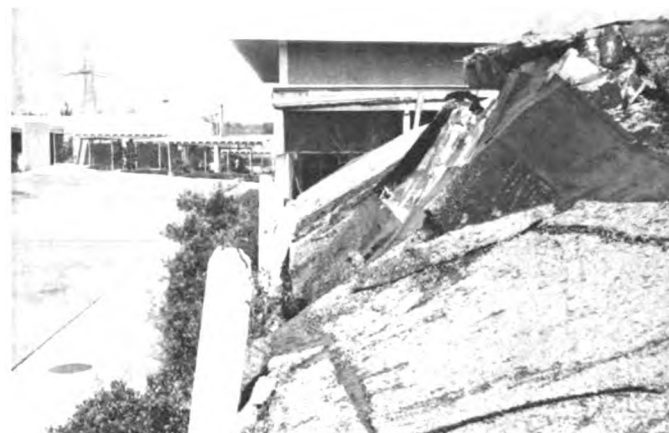
Figure 7.—San Fernando Valley Juvenile Hall, looking east along north wall line of west wing of Administration Building. Note concrete canopies in background.

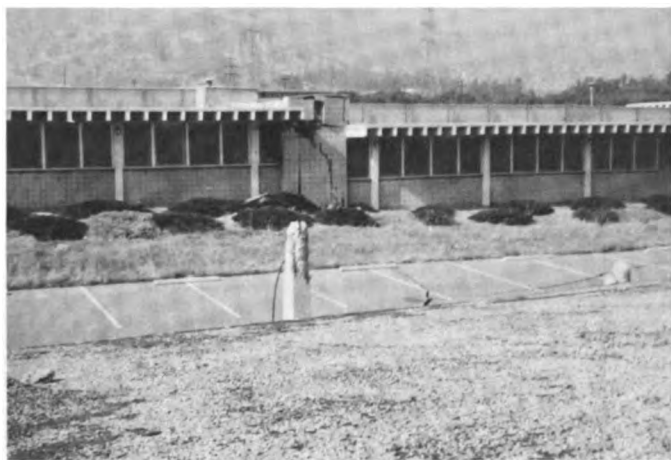
Figure 8.—San Fernando Valley Juvenile Hall, looking from roof of west wing of Administration Building, north toward living and receiving units.

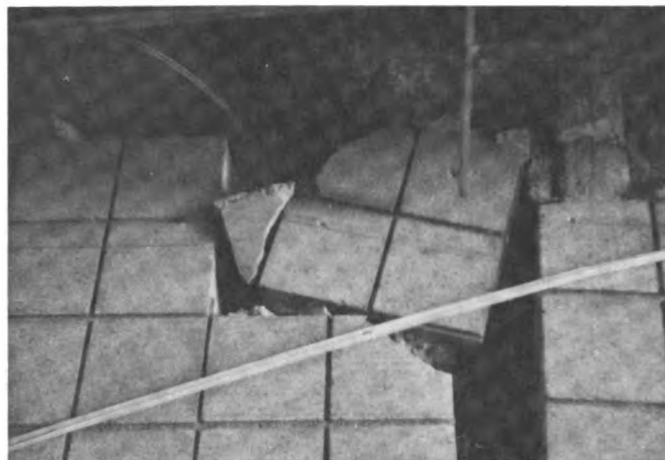
psi. The very heavy cracking (up to 12 in. wide) at this point and the evidence of horizontal movement (approximately 8 in.) of parts of the wall seem to indicate that the building shear wall system failures began along this wall line and probably precipitated other failures in the building. Special jamb reinforcing at openings was detailed on the drawings but could not be located when inspecting the wall.

Figure 10.—San Fernando Valley Juvenile Hall. West wing of Administration Building. Massive cracking between duct holes in 12-inch block shear wall.

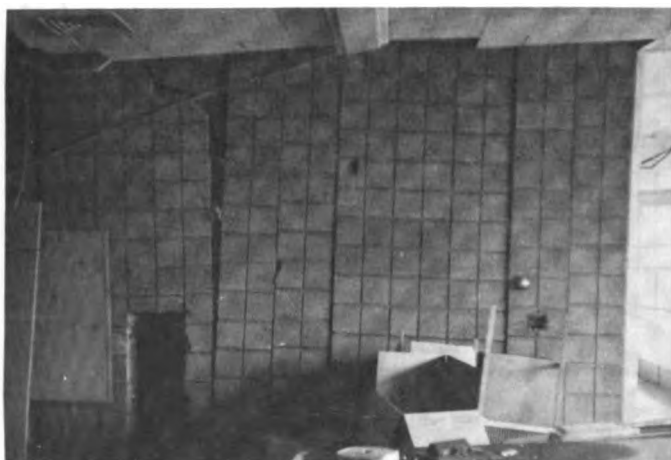
Figure 9.—San Fernando Valley Juvenile Hall. West wing of Administration Building, looking at south end of 12-inch block shear wall.

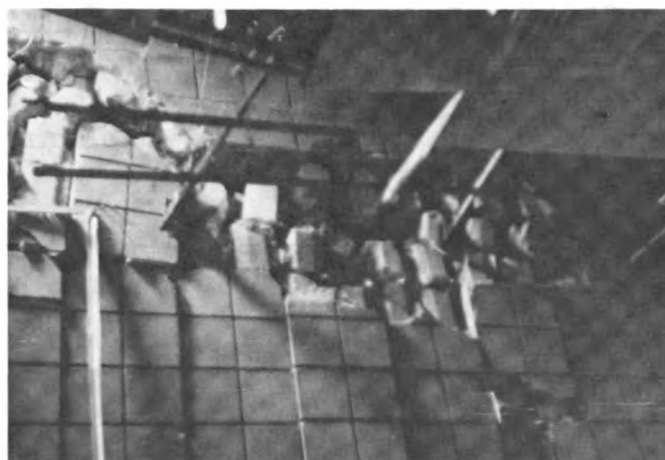
Figure 11.—San Fernando Valley Juvenile Hall. West wing of Administration Building. Massive cracking, near north end of 12-inch block shear wall, in line with duct openings.

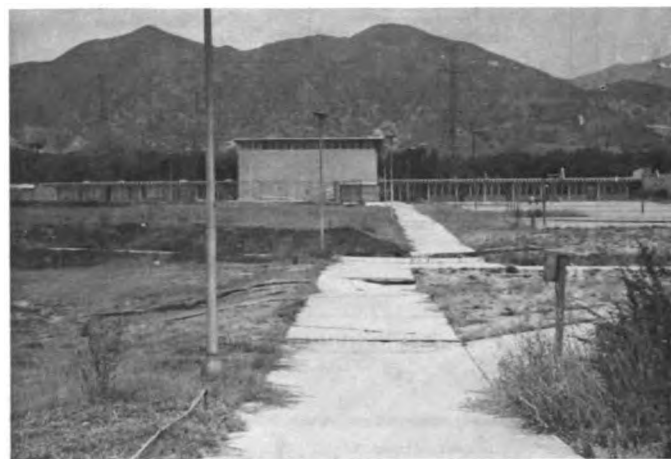
Figure 15.—San Fernando Valley Juvenile Hall. Boys' school and gymnasium, looking north at gym and two classroom wings. Note ground ruptures in foreground.

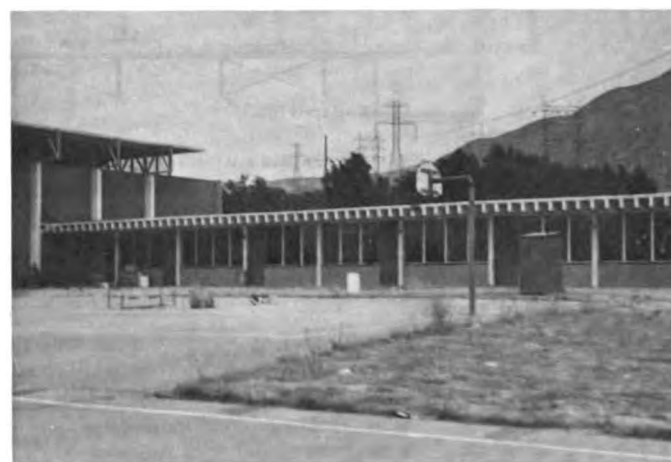
Figure 16.—San Fernando Valley Juvenile Hall. Boys' school and gymnasium, looking north at east wing of classroom building. No significant damage.

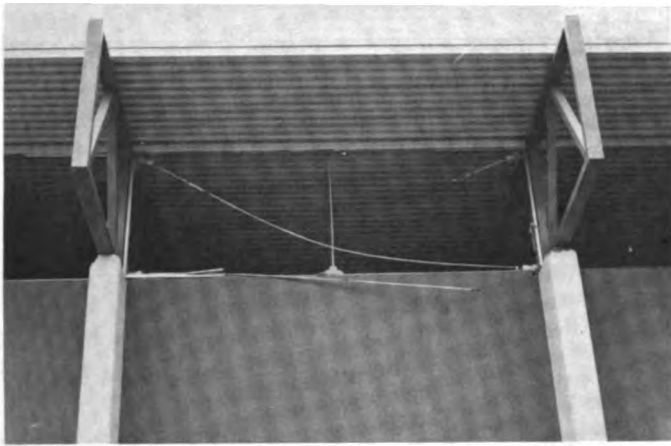
Figure 17.—San Fernando Valley Juvenile Hall. Boys' school and gymnasium, east wall of gym. Failed rod bracing.

The west-end wall and the diagonal rods at the gym roof represent the "weak link" in the seismic-resisting system. Their failure indicates a gross seismic overload many times the code-prescribed forces.

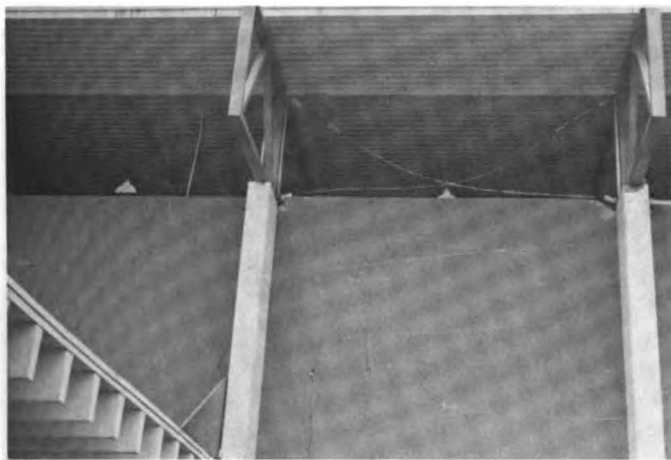
Figure 18.—San Fernando Valley Juvenile Hall. Boys' school and gymnasium, west wall of gym. Failed rod bracing and cracks in concrete wall panel.

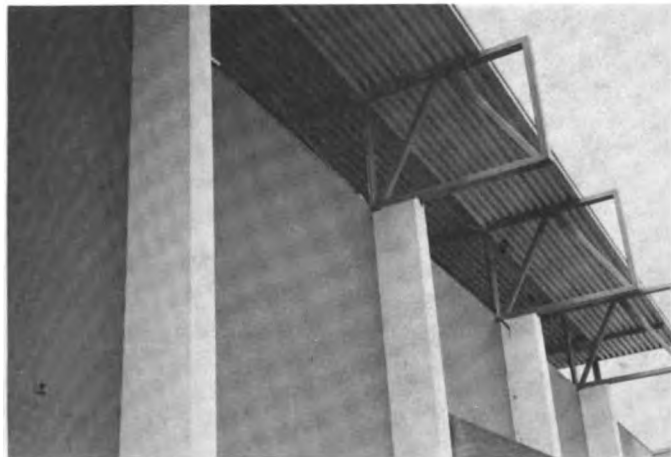
Figure 19.—San Fernando Valley Juvenile Hall. Boys' school and gymnasium, east wall of gym. Note cracks and spalling in concrete column.

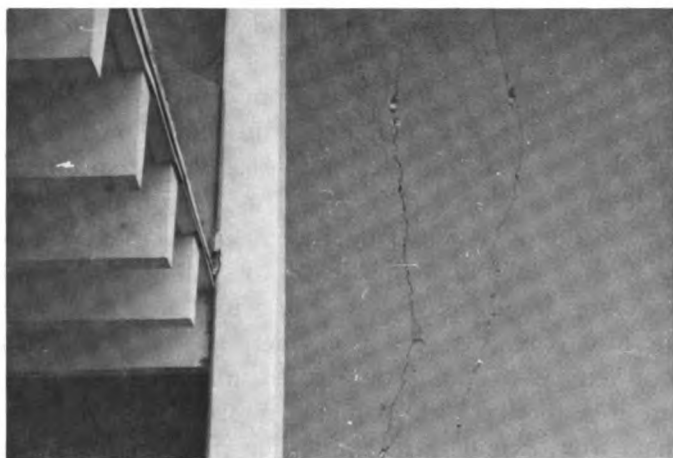
**Figure 20.**—San Fernando Valley Juvenile Hall. Boys' school and gymnasium. Wall cracks in west wall of gym. Note "hammering" effect on low roof.

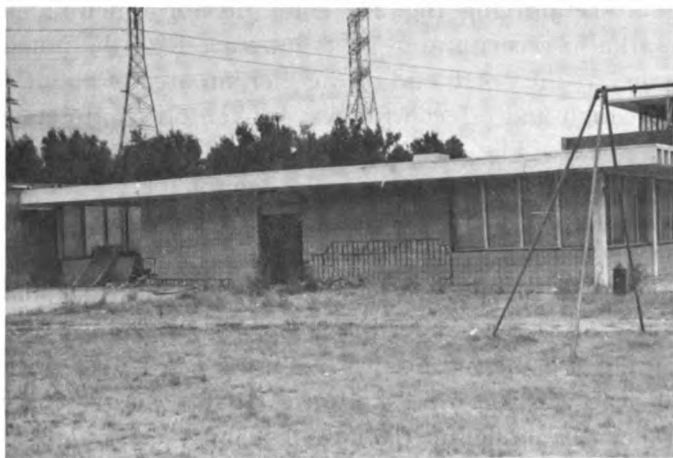
The west wing of the classroom building was damaged quite heavily at the west-end wall. The 12-inch block shear wall on both sides of the door sustained extensive fractures (fig. 21). The pier on the south side of the door was shattered, causing a large portion of the face shells of the blocks to spall off. Diagonal cracking up to about  $\frac{1}{2}$  inch wide occurred. The bottom corner of the wall pier (north side) was cracked heavily and was spalled and broken out in an area about 12 by 24 inches in size. Vertical jamb bars were exposed (fig. 22). The pier on the north side of the door was damaged; block face shells spalled off along the bottom course of the masonry units (fig. 23). The masonry wall spalled at the bottom corner at the south side of the pier, exposing jamb reinforcing (fig. 24). The interior 8-inch block wall also was ruptured at its juncture with the north pier. At the north end of the pier, an area of about 4 feet high and 5 feet wide was broken out completely (fig. 23). The 12- by 20-inch reinforced concrete bond beam over the door was completely ruptured. It sustained a diagonal crack 2 to 4 inches wide and local spalling. The parallel joists at the roof overhang also were fractured at this point with diagonal cracking (fig. 25).

The damage at the west end shear wall appeared to be the type of failure where the walls are overloaded and fail in shear. The resulting pier translation and rotation grossly overstressed the relatively rigid, common connecting member (bond beam) across the tops of the wall. The rigid concrete bond beam completely fractured over the door because of its inability to sustain rotations cranked in from the piers at each side of the opening. The piers would have been stressed to about 14 psi at code force levels. Assuming a basic shear stress of 50 psi at the "first cracks," which seems reasonable for the type of material and pier configuration, the seismic force level would have been about 47 percent of gravity at the "first cracks." Obviously, the actual stresses were quite a bit higher than "first crack" intensity, although ultimate wall capacity probably was not

**Figure 21.**—San Fernando Valley Juvenile Hall. Boys' school and gymnasium. West wall of west classroom wing.

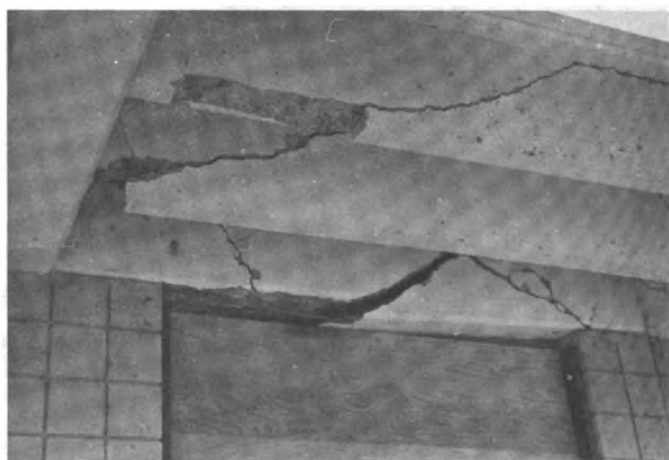
**Figure 25.**—San Fernando Valley Juvenile Hall. Boys' school and gymnasium. Concrete bond beam over door at west wall of west wing.

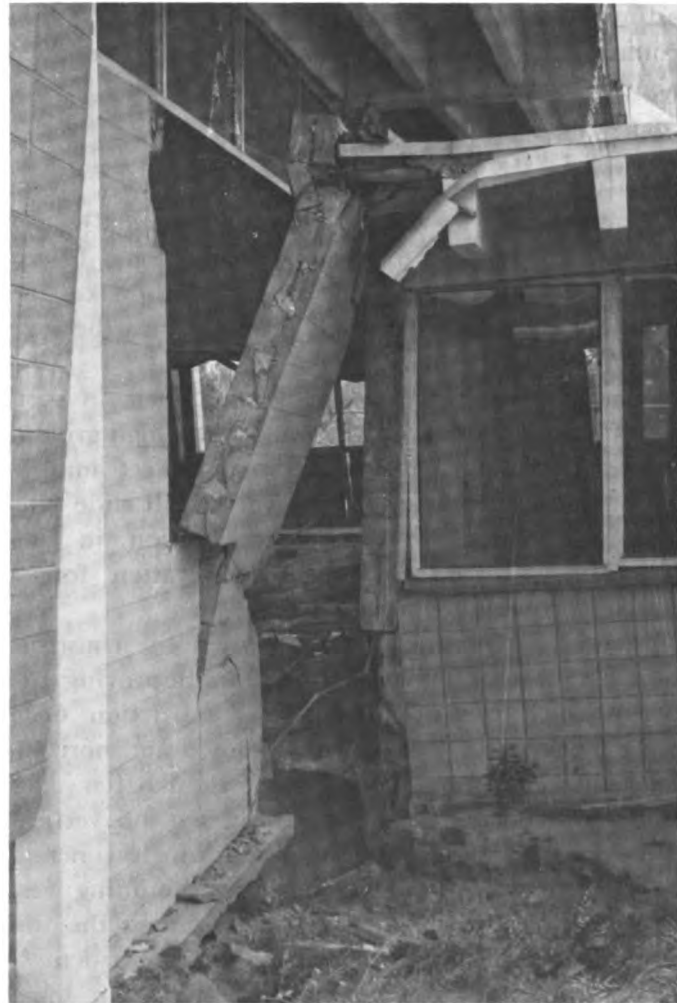
Undoubtedly, a significant portion of the damage to buildings resulted from ground rupture and/or a

combination of ground rupture and extremely high accelerations, both horizontally and vertically.

Figure 26.—San Fernando Valley Juvenile Hall.  
Ground rupture at building.

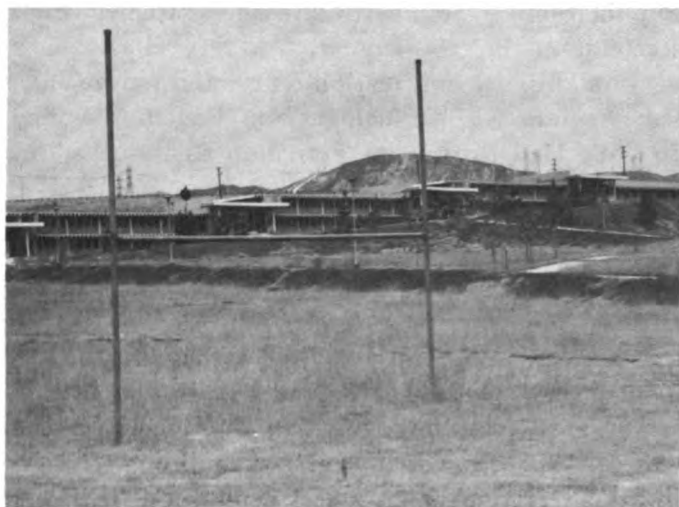
Figure 27.—San Fernando Valley Juvenile Hall. Ground rupture in foreground. Living units E in background.

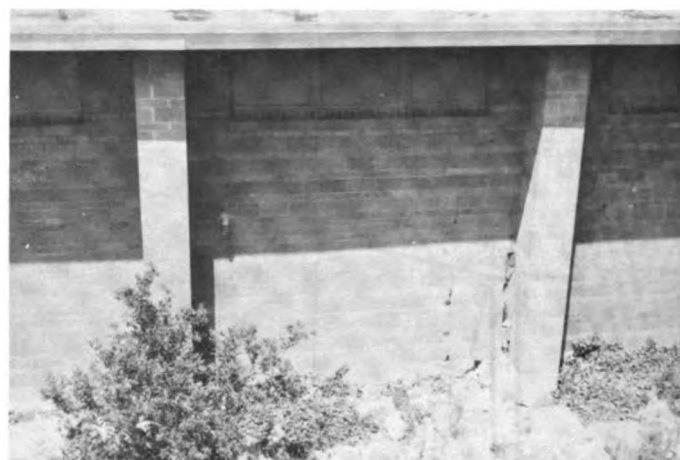
**Figure 6.**—Camp Karl Holton Juvenile Facilities. Recreation building. Large crack in east wall.

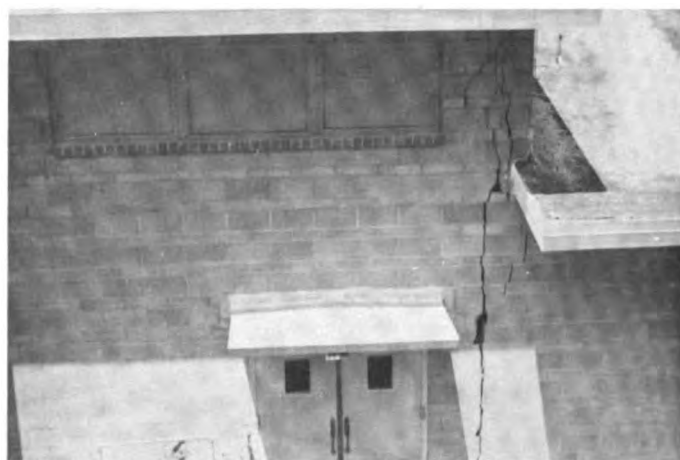
**Figure 7.**—Camp Karl Holton Juvenile Facilities. Recreation building. Wall crack at northeast corner of high roof area.

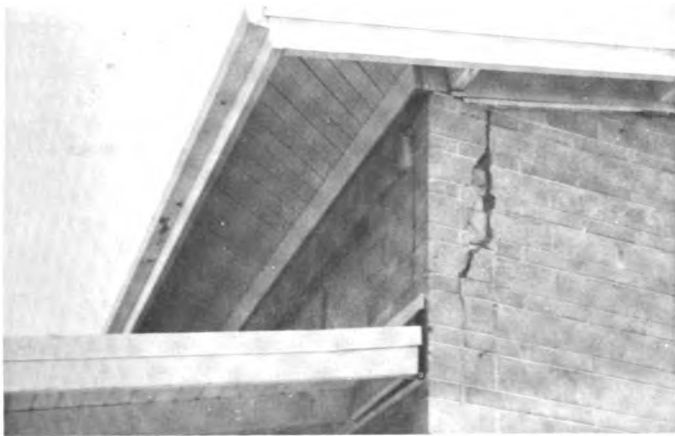
Figure 8.—Camp Karl Holton Juvenile Facilities. Recreation building. Wall cracking at southwest corner. Note separation between canopy and wall.
